TEST REPORT

Test Report # R-us4-16381834-E Date of Report Issue: November 18, 2016
Date of Sample Received: November 7, 2016 Pages: Page 1 of 5

Product Name: COB working light with magnet with hook
Model/style No.: P513.024
Main Material: -
Buyer: -
Supplier: -
Country of Distribution: N/A
Testing Period: 11/07/2016-11/18/2016

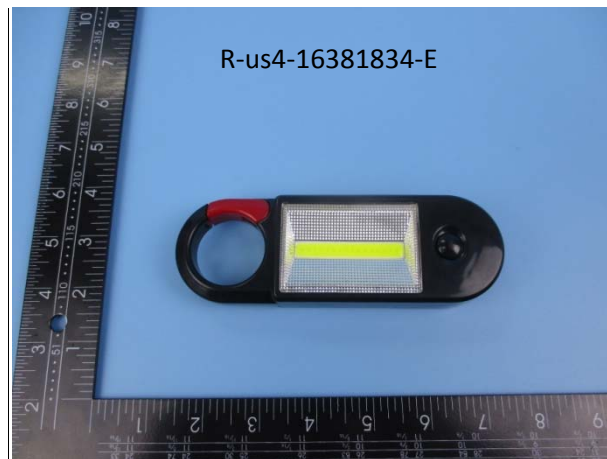
SAMPLE PHOTO:

Sample No.	Specimen No.	Specimen Description	Location
001	-	Black rubber button	-
002	-	Black plastic lamp body	-
003	-	001+002	-
