TEST REPORT

Sample Name	: Outdoor speaker	
Sample Type	: XO-9123	
Sample Quantity	: 1pc	
Sample Received Date	: Jun. 21, 2017	
Sample tested Date	: Jun. 23, 2017

Test Item: IPX4 test

3) Test standard: IEC 60529:1989+A1:1999+A2:2013

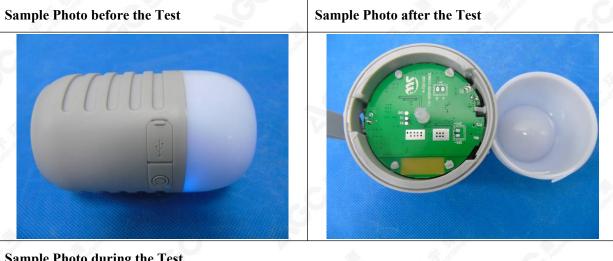
Sample Photo during the Test

- 1. Radius of the tube: 200mm.
- 2. Water flow rate : 0.91L/min.
- 3. The rotation speed of the turntable: 1RPM.
- 4. Test duration: 10min.
- 5. The tube is caused to oscillate through an angle of almost 360° , 180° on either side of the vertical, the time for one complete oscillation (2 × 360°) being about 12 s.

Sample No.	Test result description	Conclusion
001	After the test, by visual inspection, there was no water into the sample inside	Pass
