Determination of Hazardous Substances TEST REPORT

Report No. : MTi190301S005

Products : Fabric trend speaker

Model/P.O NO. : P328.21

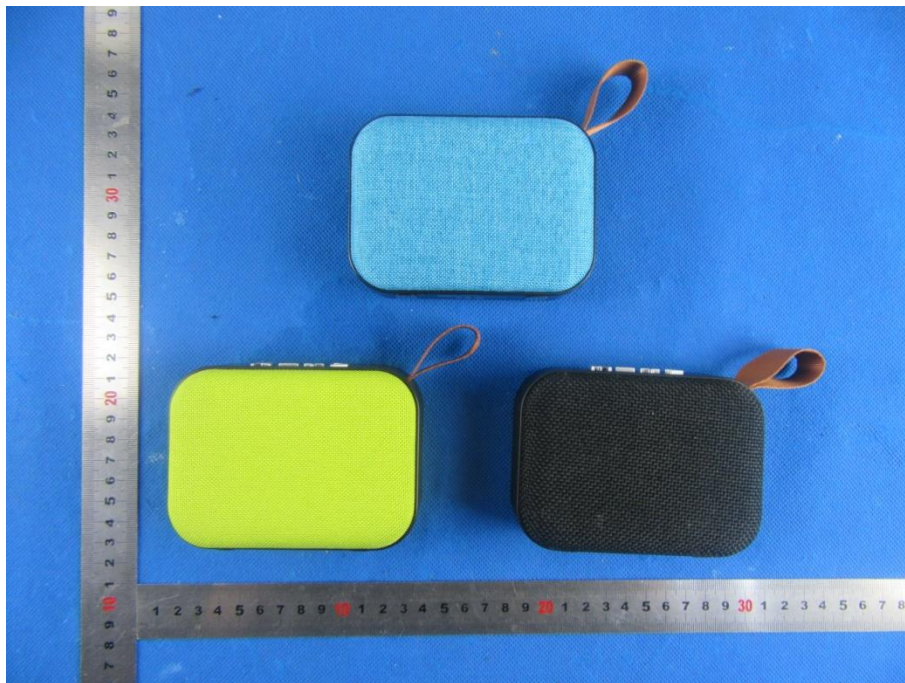
Photo 1

- ☒ General
- ☐ front
- ☐ rear
- ☐ right side
- ☐ left side
- ☐ top
- ☐ bottom
- ☐ internal

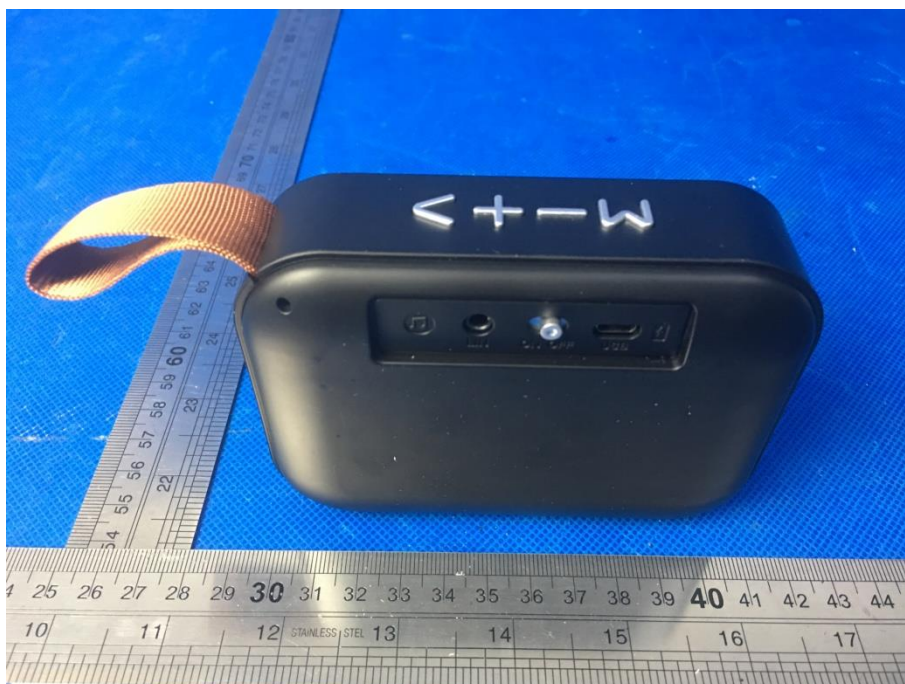
Photo 2

- ☒ General
- ☐ front
- ☐ rear
- ☐ right side
- ☐ left side
- ☐ top
- ☐ bottom
- ☐ internal
