TEST REPORT

Test Report # 18A-000207
Date of Sample Received: January 22, 2018

Product Name: Leak proof silicone toiletry bag
Model/style No.: P703.03*
Main Material: silicone
Buyer: -
Supplier: -
Country of Distribution: EU
Testing Period: 01/22/2018-01/24/2018

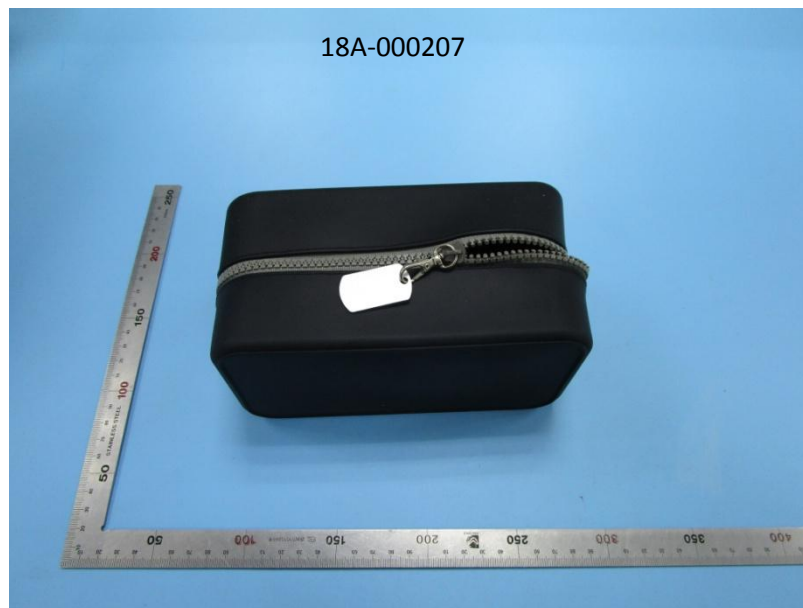
SAMPLE PHOTO:

Specimen No.	Specimen Description	Location
1	Black silicone	Main body of black style
